ESSEX COUNTY COUNCIL

ASSESSMENT REPORT

FINCHINGFIELD BRIDGE

BRIDGE No: 26

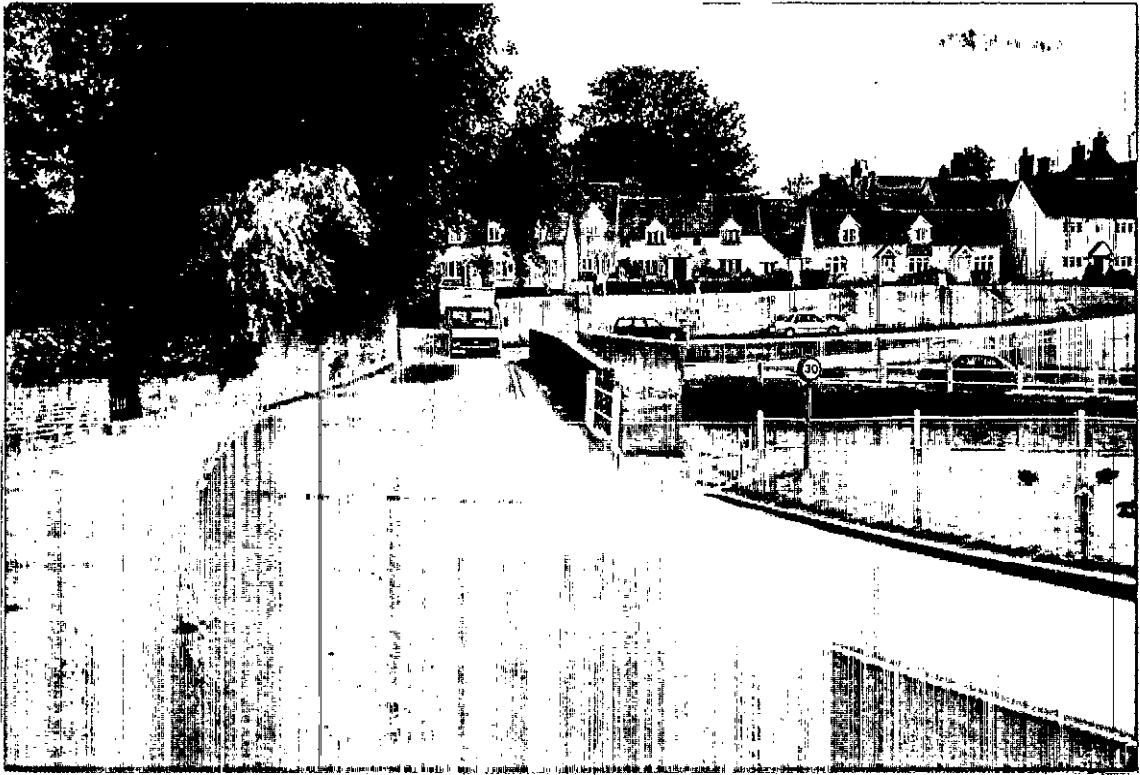
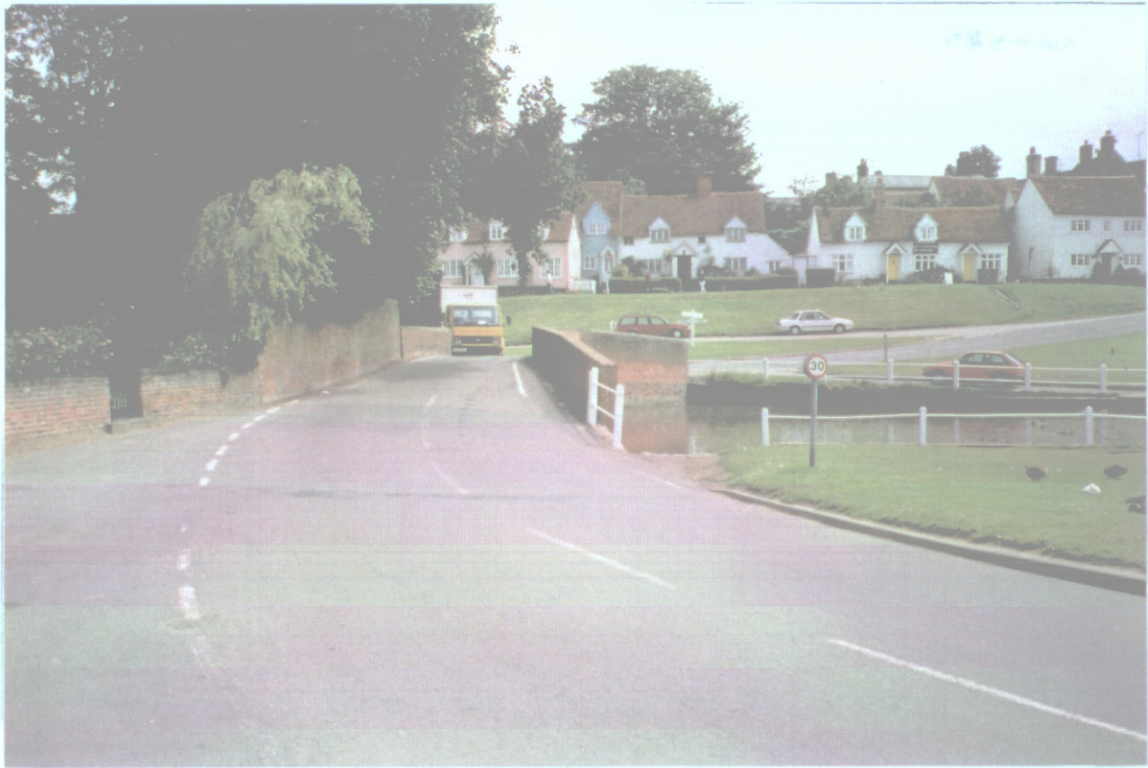
The Bridge carries the B1053/1057 over Finchingfield Brook, with a considerable hump in the road levels over the structure (see photographs 1 and 2).

Photograph 1. Carriageway looking east.

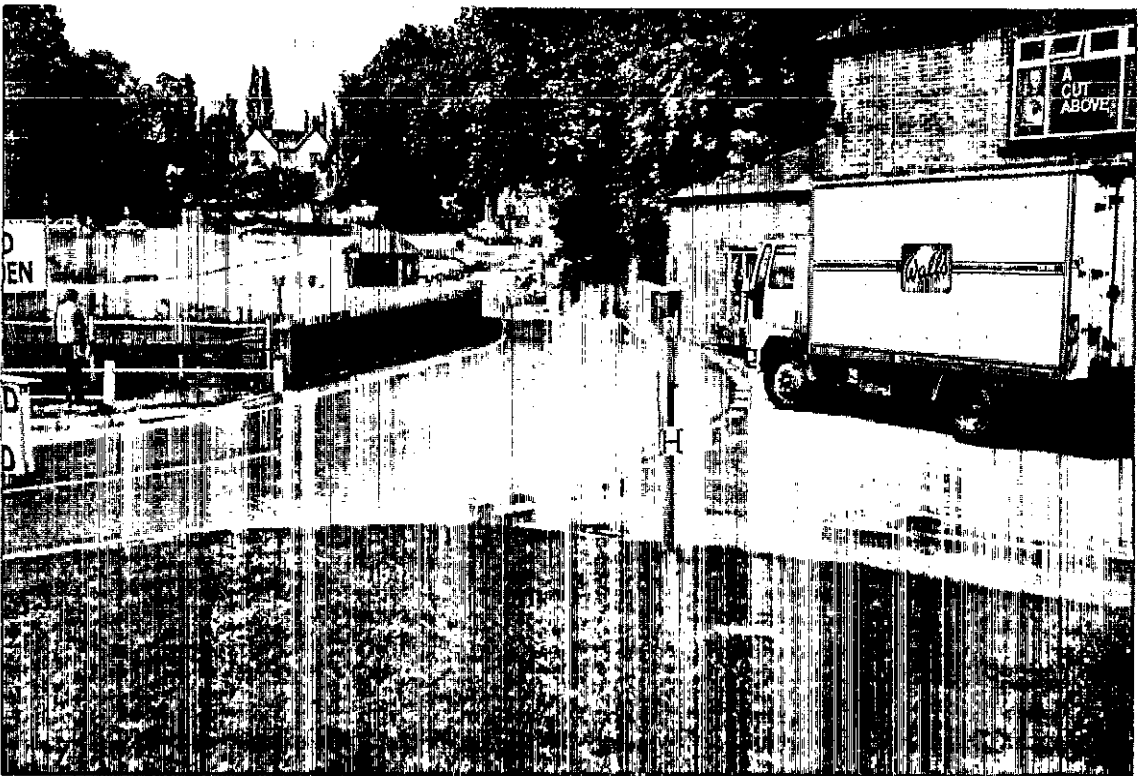
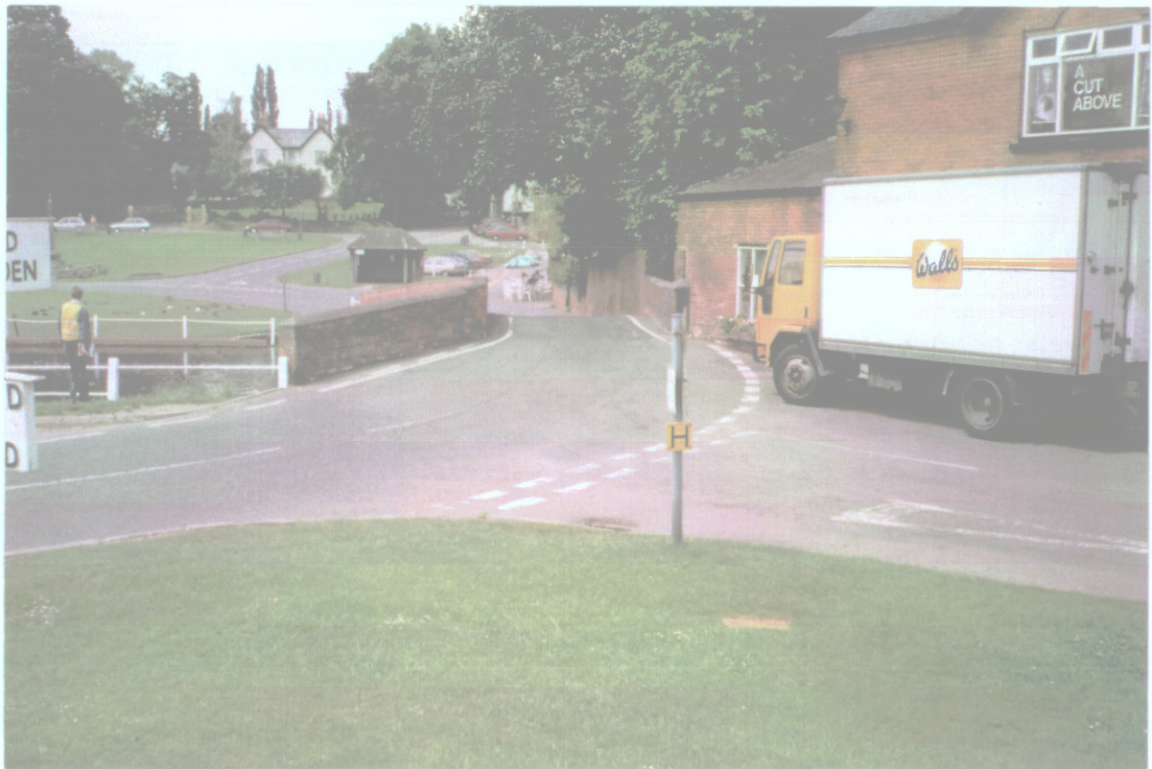
Photograph 2. Carriageway looking west.

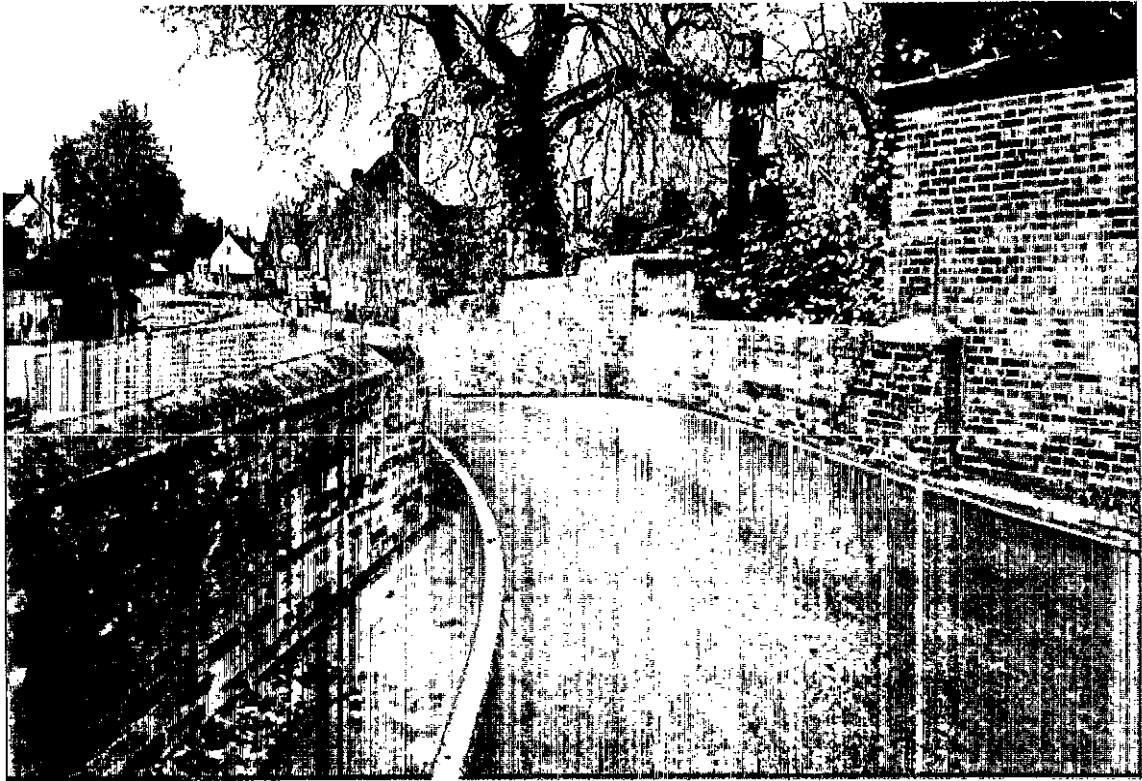
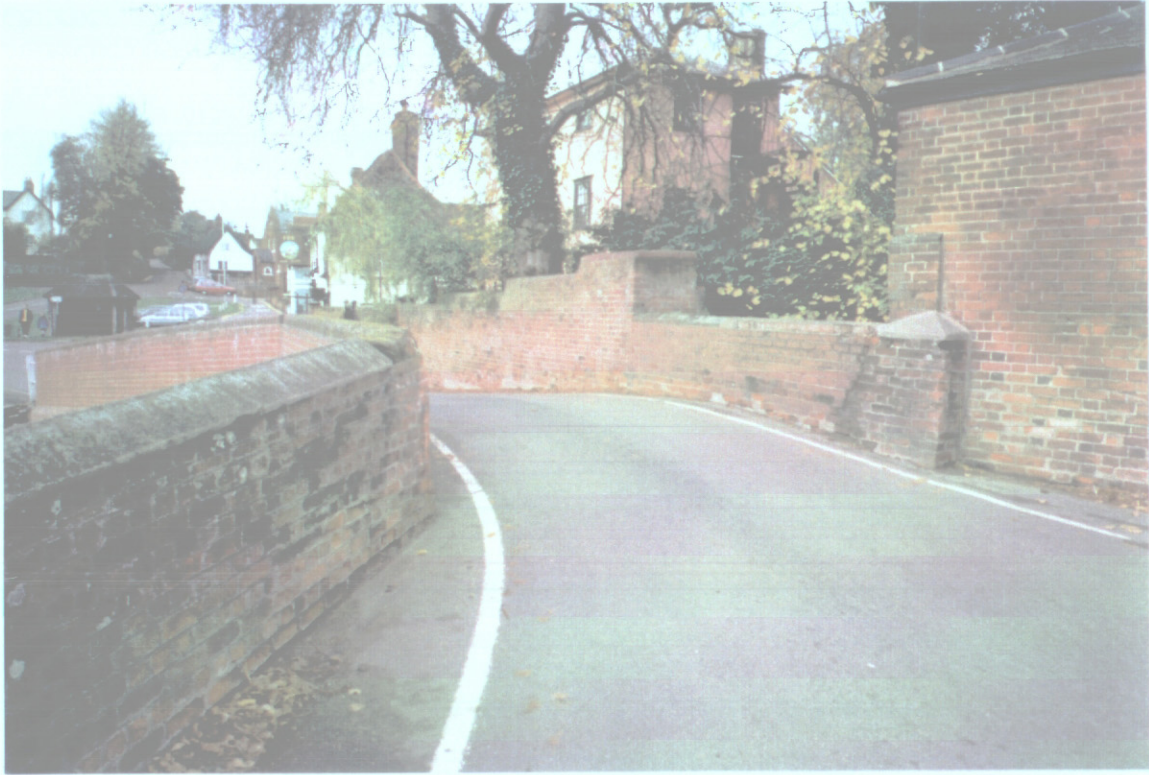
The carriageway is gouged and there are significant areas where the surfacing has 'broken-up' (*). There is a crack, adjacent to the single storey building, in the upstream parapet (see photograph 3).

Photograph 3. Downstream parapet/carriageway.

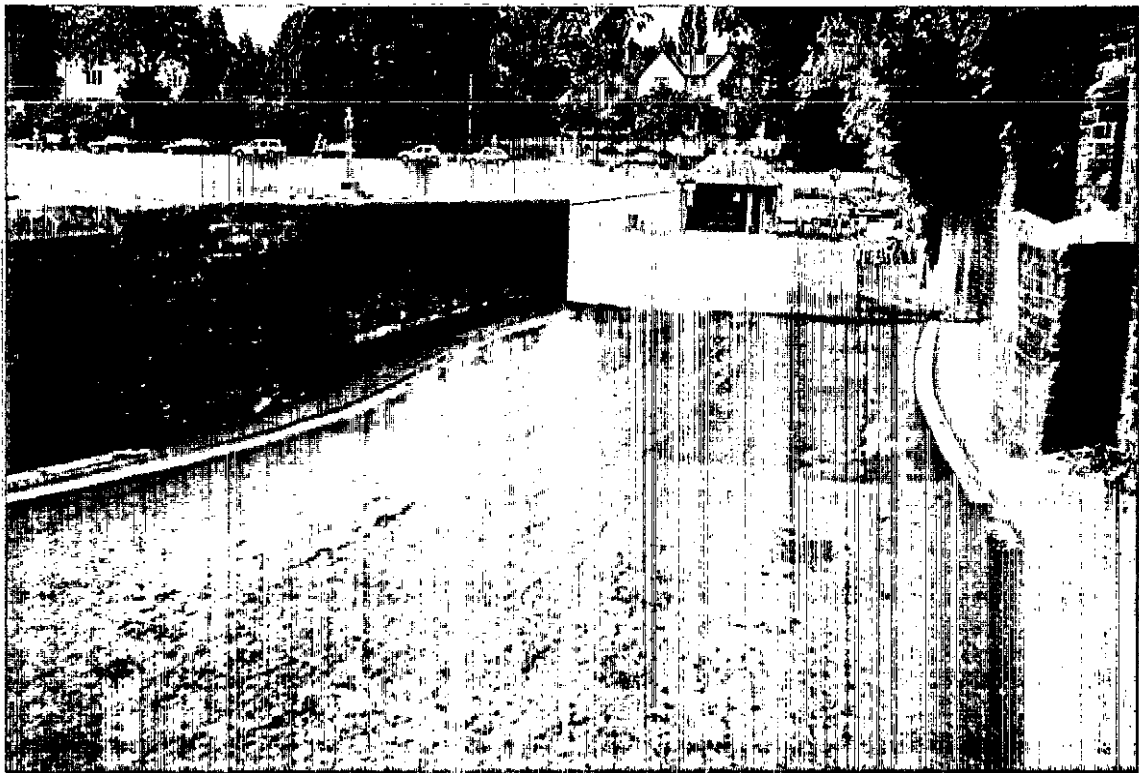
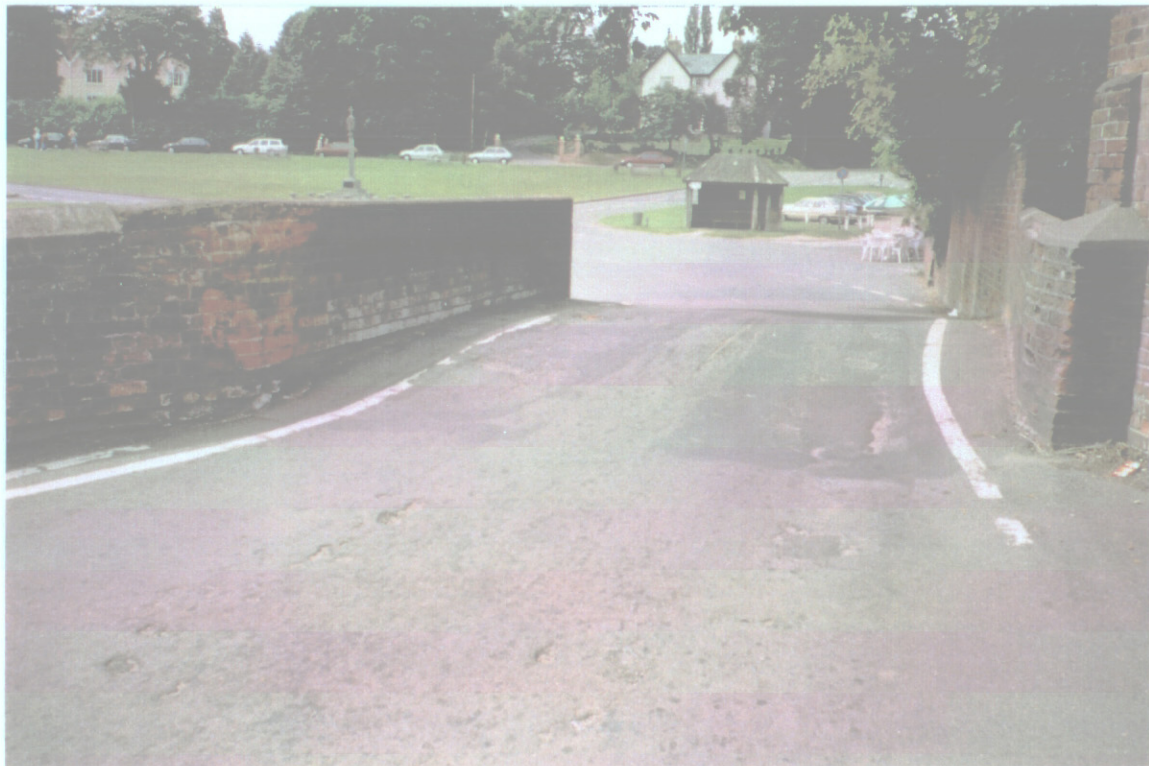
The internal (south-east) corner of the downstream parapet has been gouged by vehicular traffic (see photograph 4).

Photograph 4. Upstream parapet.

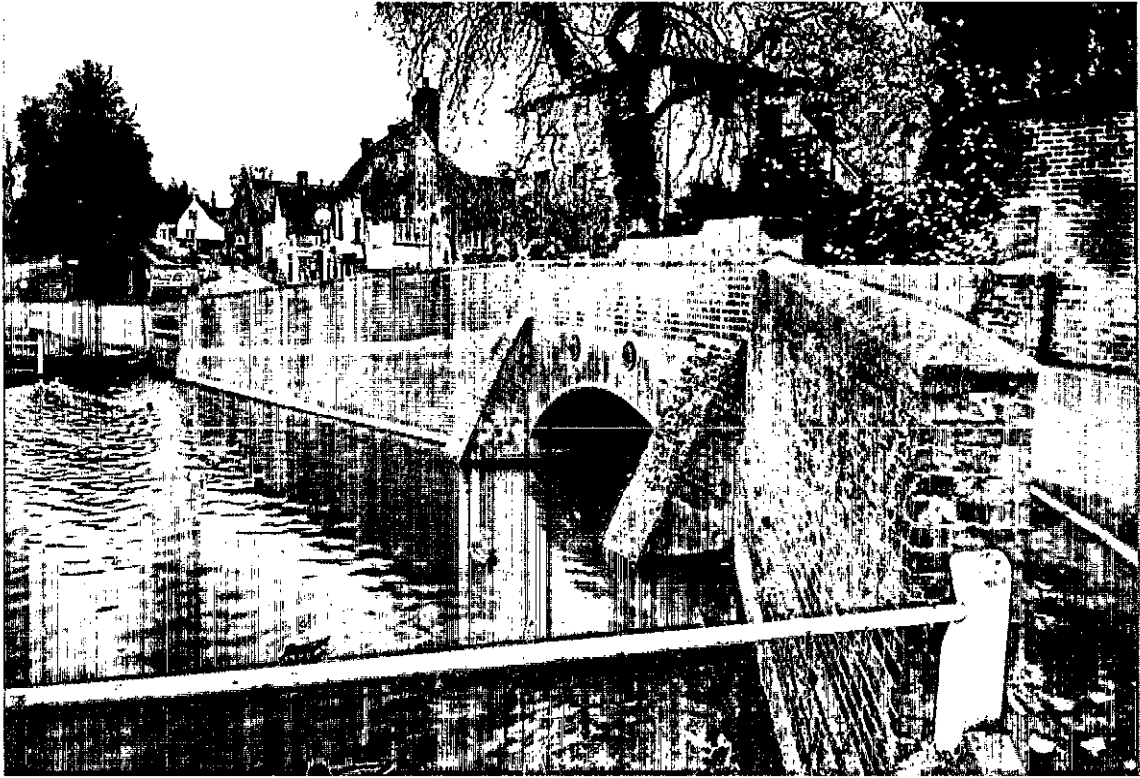
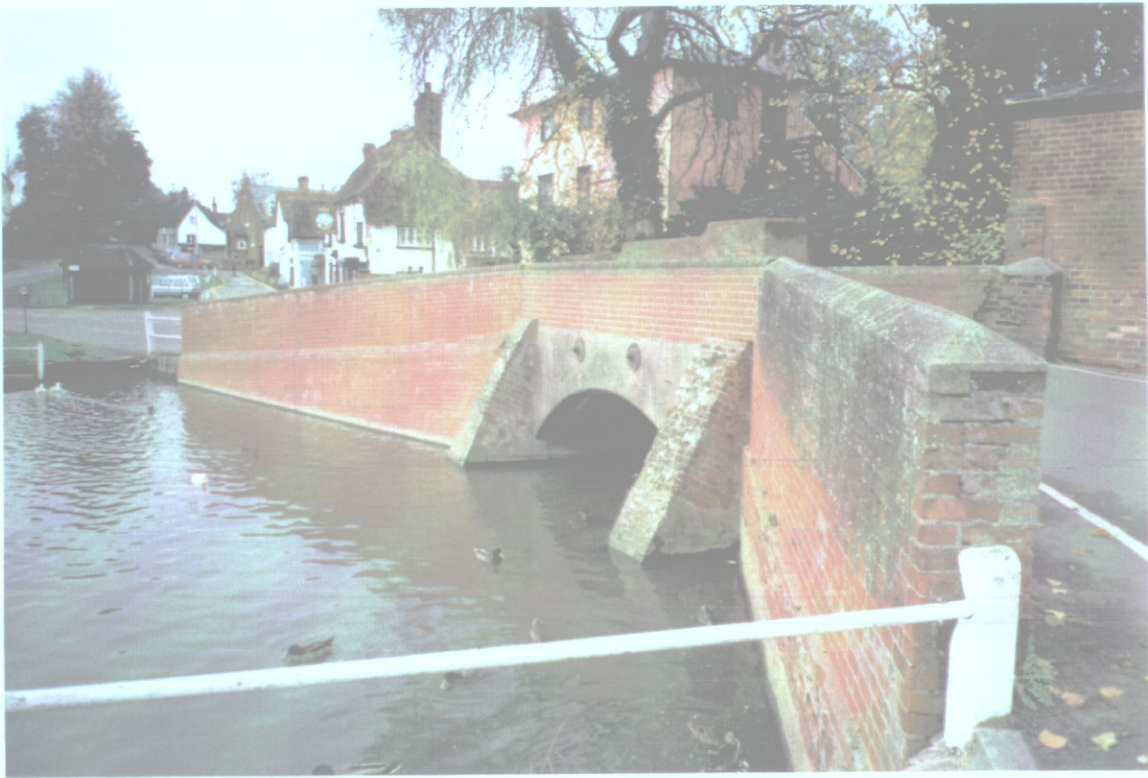
The downstream parapet and wingwall have been rebuilt in recent years. The Bridge is part of a very picturesque group around the village pond (see photograph 5).

Photograph 5. Downstream parapet/wingwall.

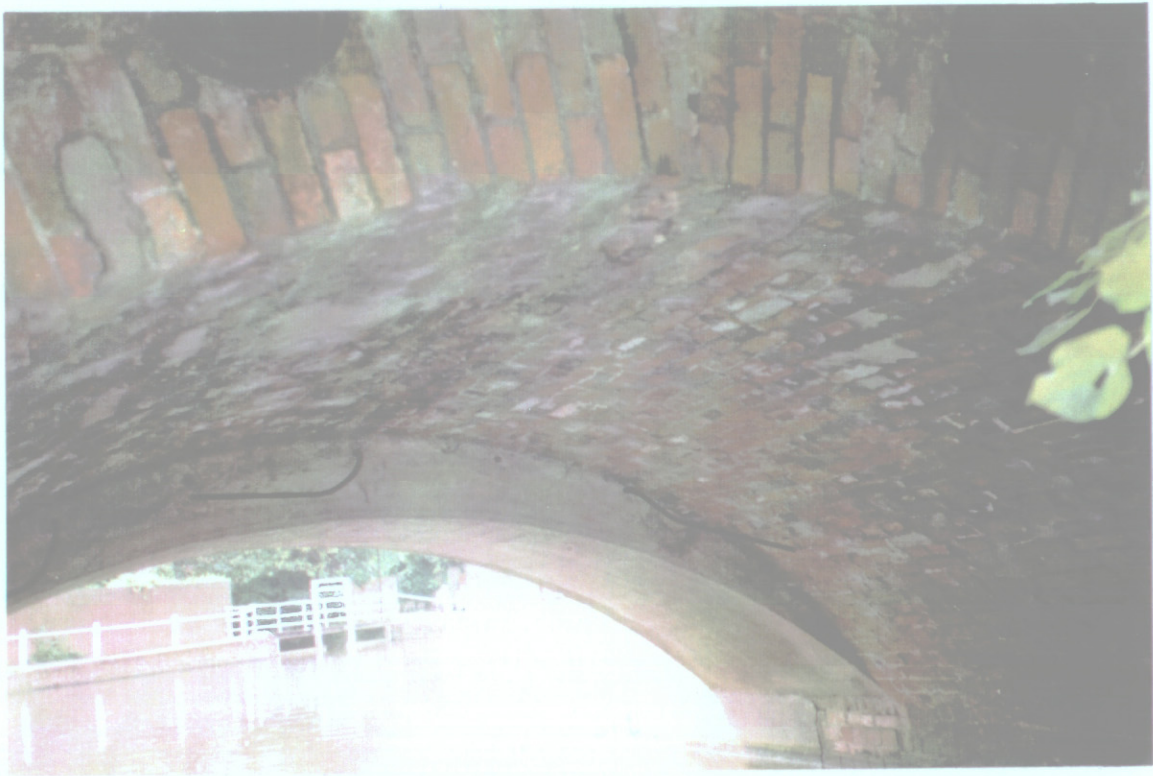
The brick arch shape is generally good and a condition factor of 0.9 is considered appropriate.

The brick arch shape is generally good and both the voussoir and barrel joints have been repaired and repointed on a number of occasions. There are some longitudinal cracks through the barrel joints and there are white deposits on some of the bricks, presumably efflorescence (see photographs 6 and 7).

Photograph 6. Upstream brick arch.

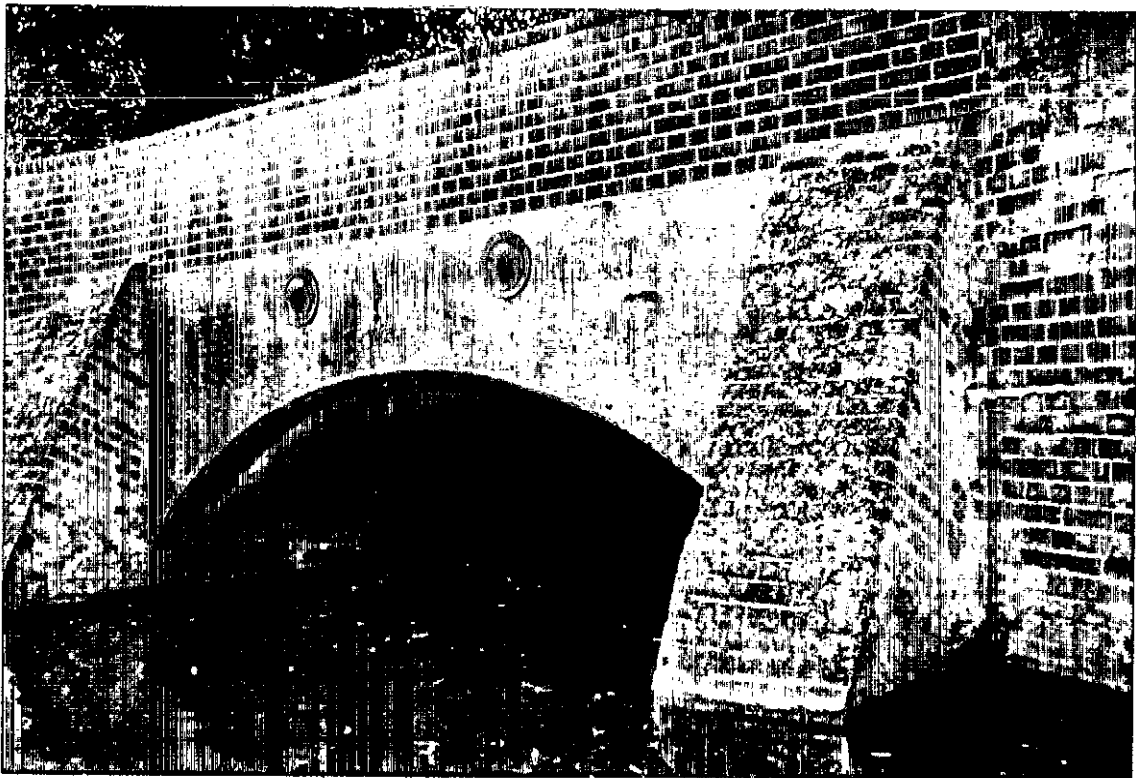
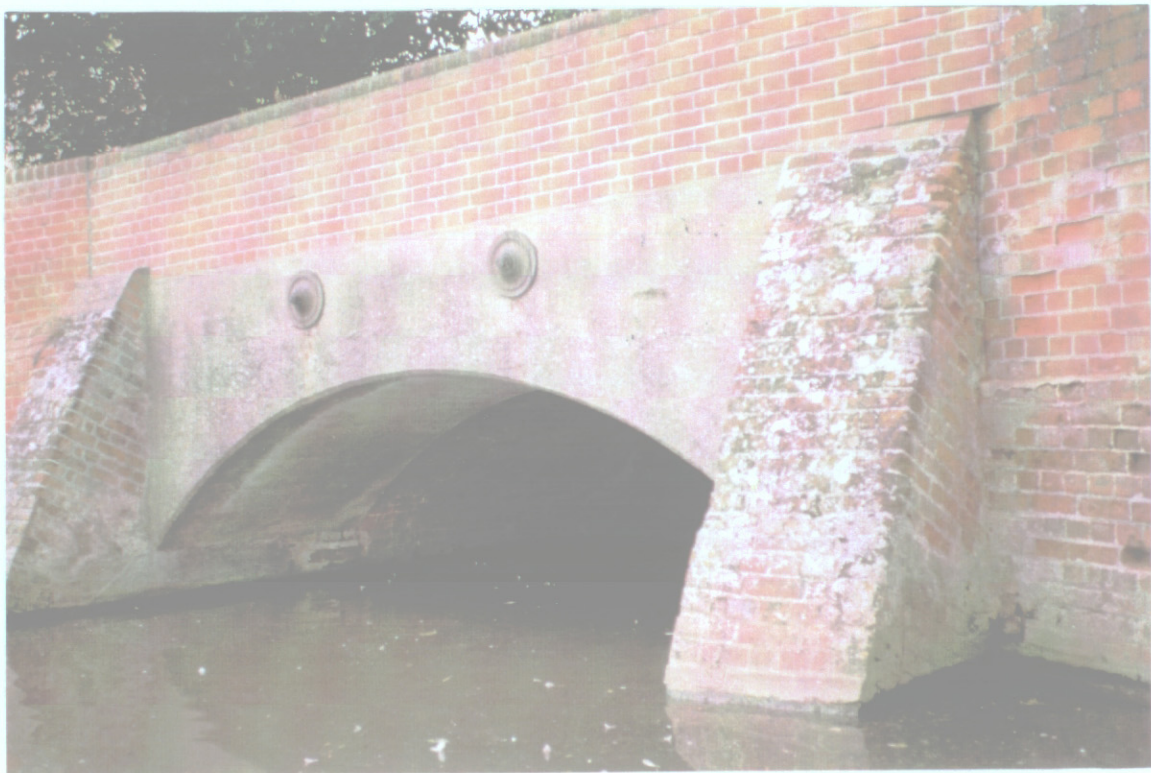
The downstream concrete extension is in good condition and is heavily buttressed at the abutments (see photograph 8).

Photograph 8. Downstream extension.

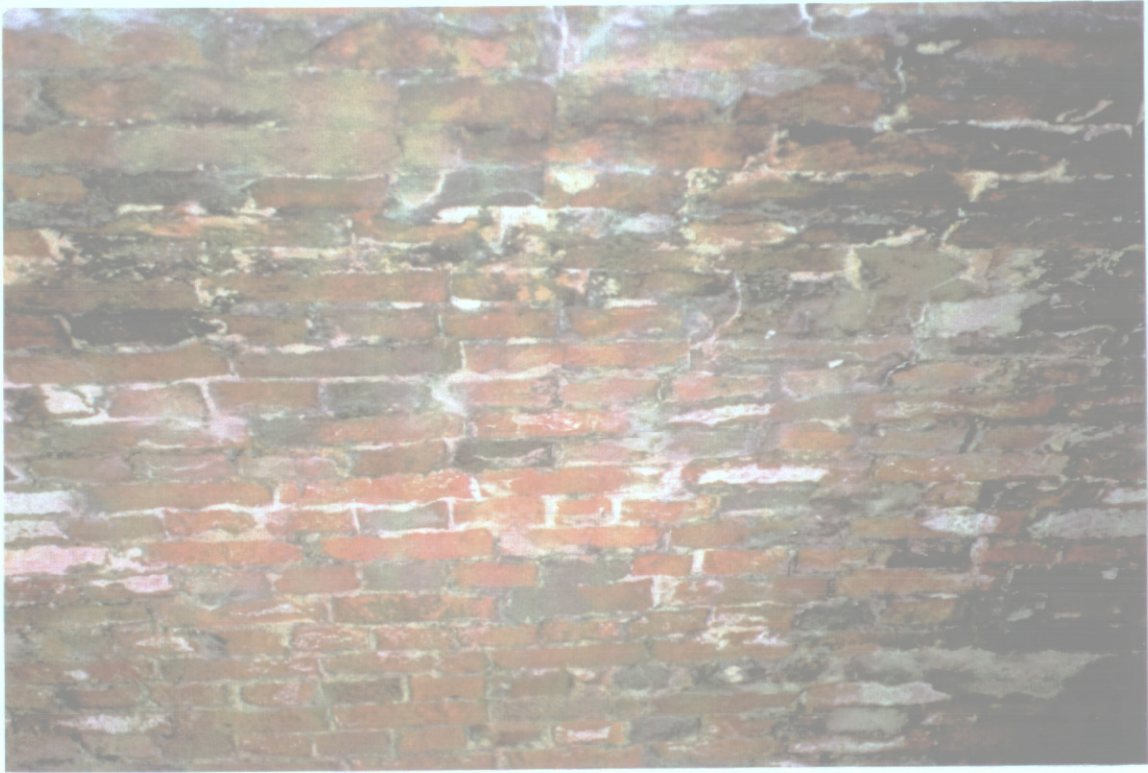
The brickwork forming the arch barrel is weathered but in a fair condition. The mortar joints are of random thickness and have been repointed periodically. There are a number of minor localised longitudinal cracks through the mortar.

Photograph 7. Barrel brickwork.
