General Inspection Report

Structure Name: FINCHINGFIELD

Identifier: 26

Inspection Date: 15/07/2022

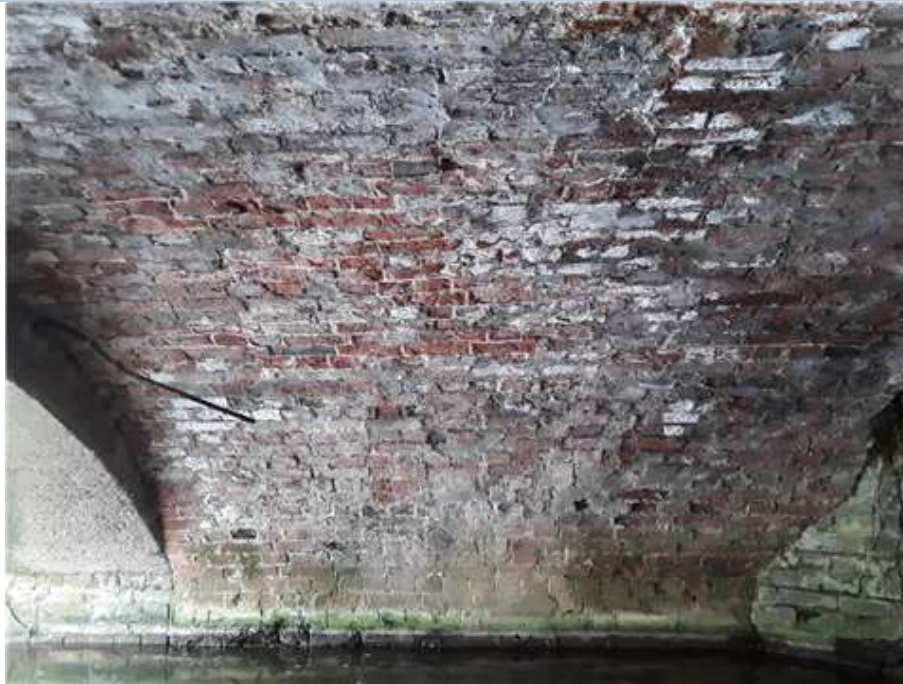
West Haunch
 - Minor weathering affecting approximately 60% of brick faces.
 - There are multiple historic mortar repairs which are generally in good condition.

Comment	Remedial Works
- Minor weathering affecting approximately 60% of brick faces. - There are multiple historic mortar repairs which are generally in good condition.	[none]

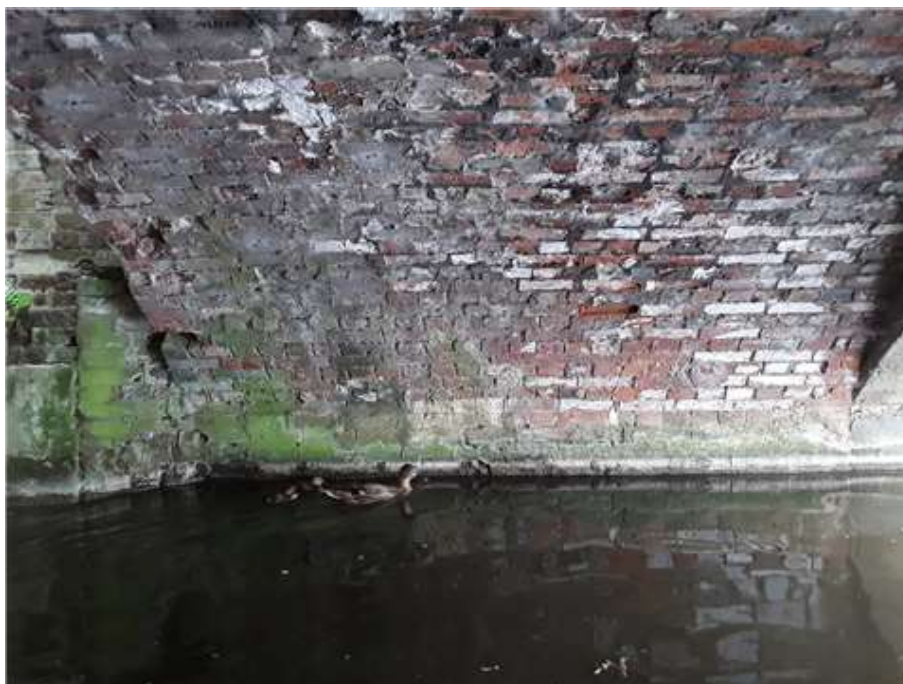
East Haunch
 - Minor weathering affecting approximately 60% of brick faces.
 - There are multiple historic mortar repairs which are generally in good condition.

Comment	Remedial Works
- Minor weathering affecting approximately 60% of brick faces. - There are multiple historic mortar repairs which are generally in good condition.	[none]

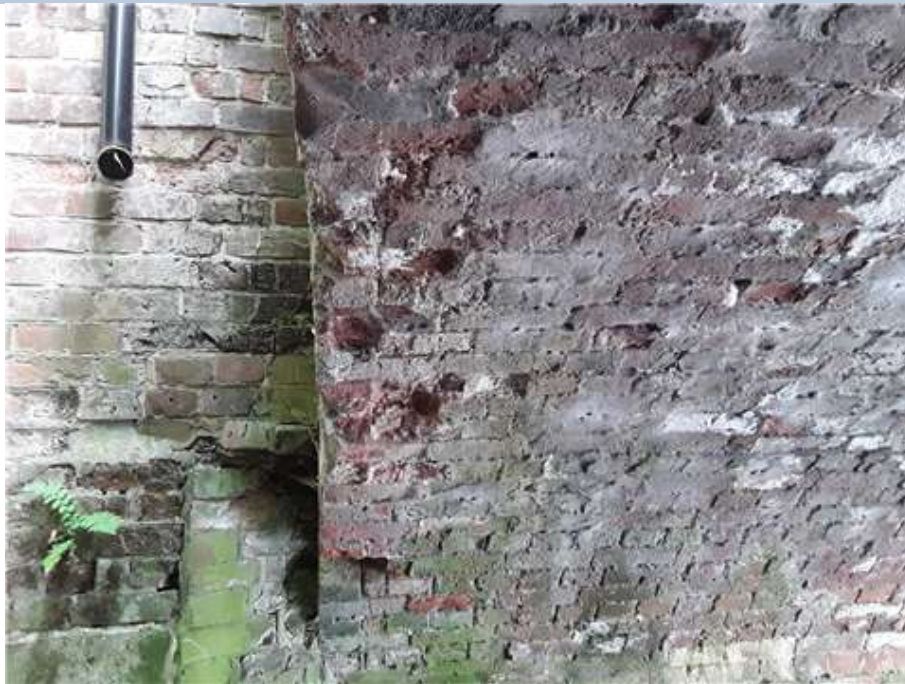
East Haunch, Northern End - Moderate Weathering to Brickwork

At the Northern end of East Haunch, patch of moderately weathered brickwork (1m x 0.25m) with 1no. missing brick to arch ring.

Comment	Remedial Works
At the Northern end of East Haunch, patch of moderately weathered brickwork (1m x 0.25m) with 1no. missing brick to arch ring.	[none]

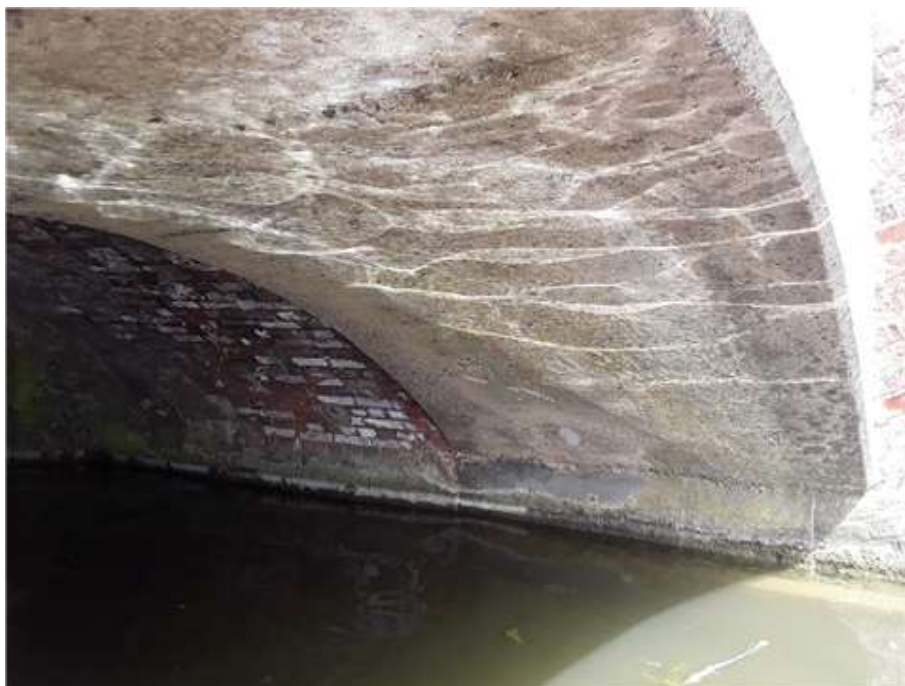
Reinforced Concrete Arch
null

Comment	Remedial Works
Concrete arch is generally in good condition. However, 2no. lengths of rebar have been left protruding from northern side of deck.	[none]

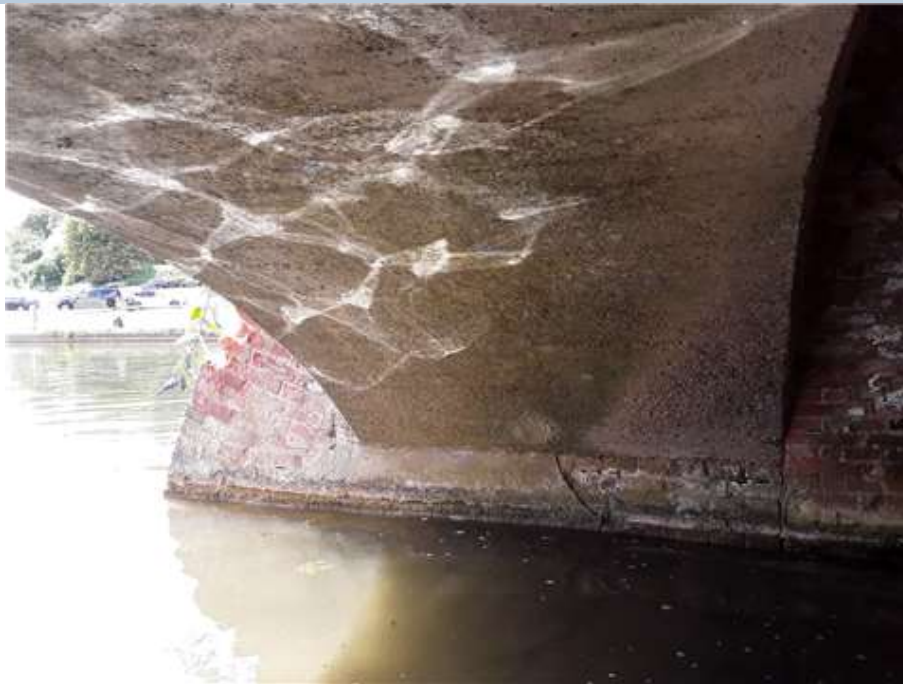
South West - Failure of Render
 Concrete finish at South West (under concrete arch) has failed. Revealed brickwork is in good condition.

The abutments were mostly below water level on day of inspection with only 300mm exposed. - Exposed abutments showed few small isolated patches of weathered brick work - Concrete finish at South west (under concrete arch) has failed. Revealed brickwork is in good condition.	[none]
--	--------

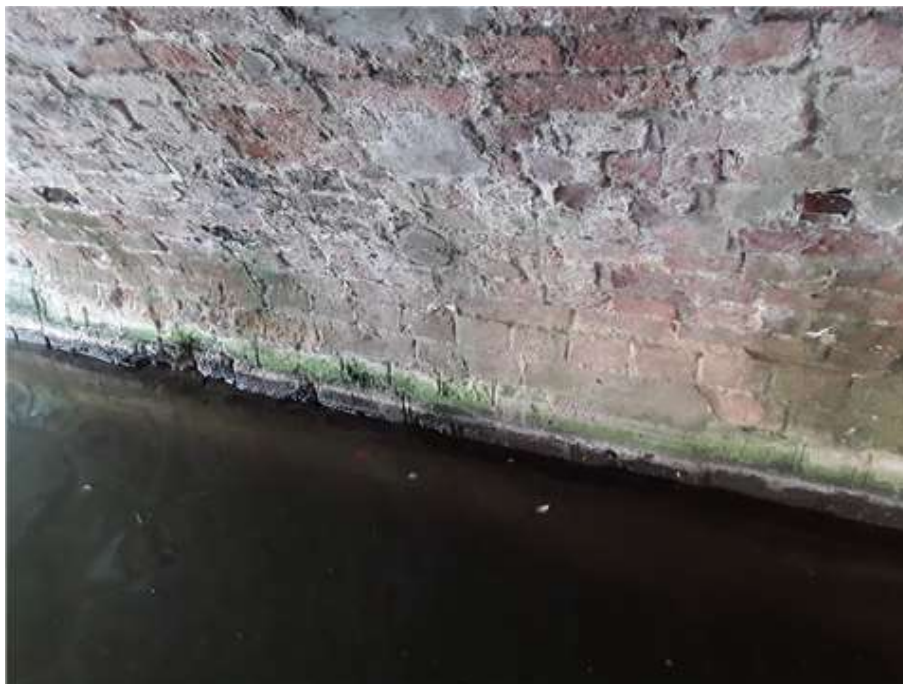
Weathered Brickwork Example
 Exposed abutments showed few small, isolated patches of weathered brick work

The abutments were mostly below water level on day of inspection with only 300mm exposed. - Exposed abutments showed few small isolated patches of weathered brick work - Concrete finish at South west (under concrete arch) has failed. Revealed brickwork is in good condition.	[none]
--	--------

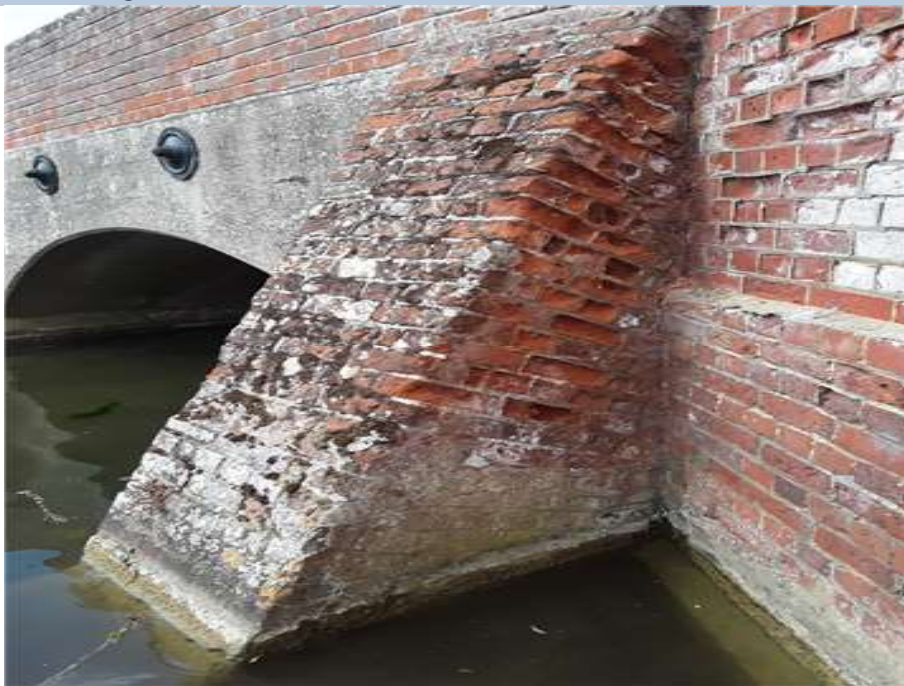
South East Buttness - Moderately Weathered Brickwork
 Both Buttnesses have moderate weathering to brick work.

Comment	Remedial Works
Both Buttnesses had moderate weathering to brickwork.	[none]

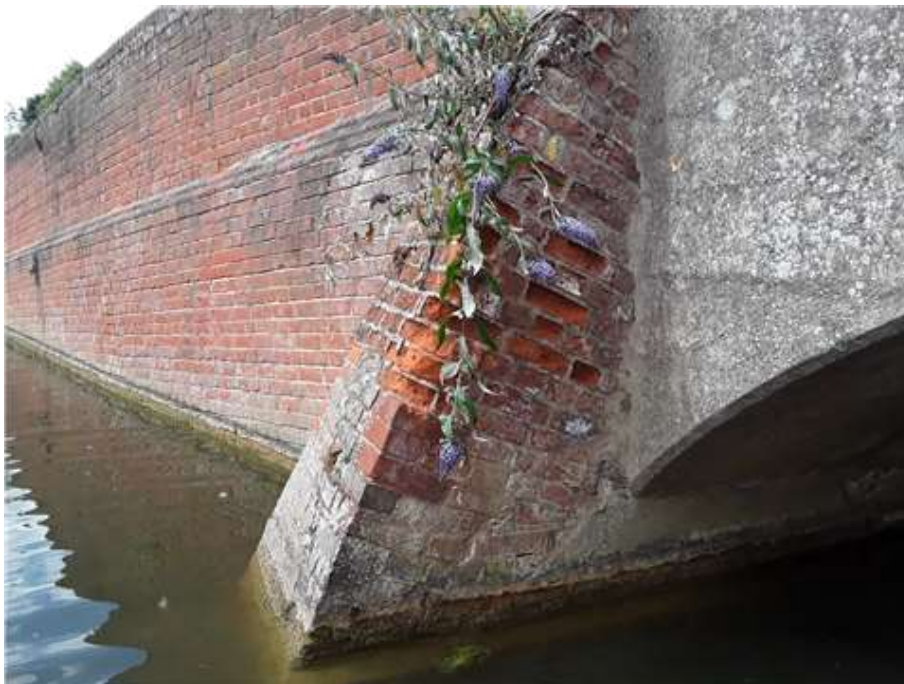
South West Buttness - Vegetation
 Weeds/ Shrub growing from South West abutment. Plant is Buddleia (Butterfly Bush) and will likely contribute to deterioration of brickwork.

Comment	Remedial Works
Weeds/ Shrub growing from South West buttness. Plant is Buddleia (Butterfly Bush) and will likely contribute to deterioration of brickwork.	Remove vegetation and prevent from further growth.

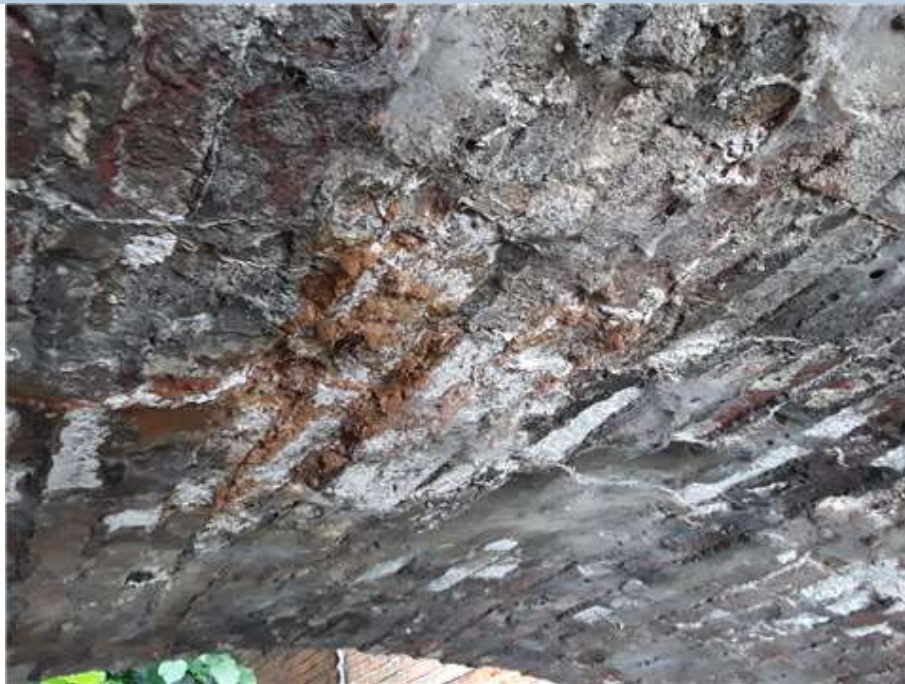
Crown - Example of Historic Seepage
 Seepage through brickwork evident in leachate and calcite deposits on brick faces.

Comment	Remedial Works
Waterproofing is unlikely to be present over arch. All elements were dry on day of inspection. However, historic seepage through brickwork evident in leachate and calcite deposits on brick faces.	[none]

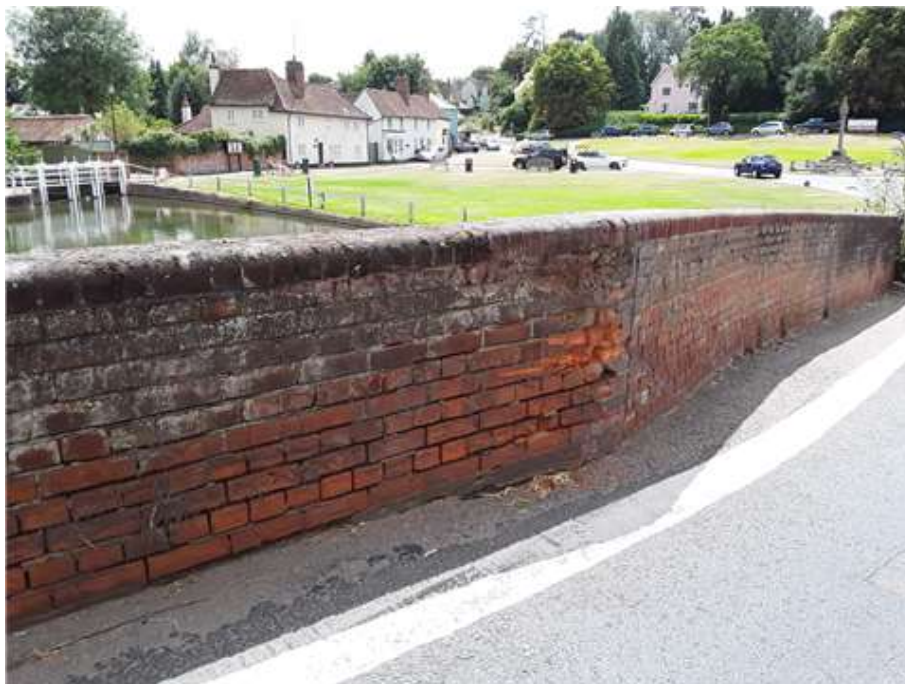
South Parapet
 Moderate loss of pointing to lower courses of inside face.

Comment	Remedial Works
- South parapet has moderate loss of pointing to lower courses of inside face. - Minor deterioration of pointing to lower courses of brickwork on inside face of parapet.	Repoint Parapet.

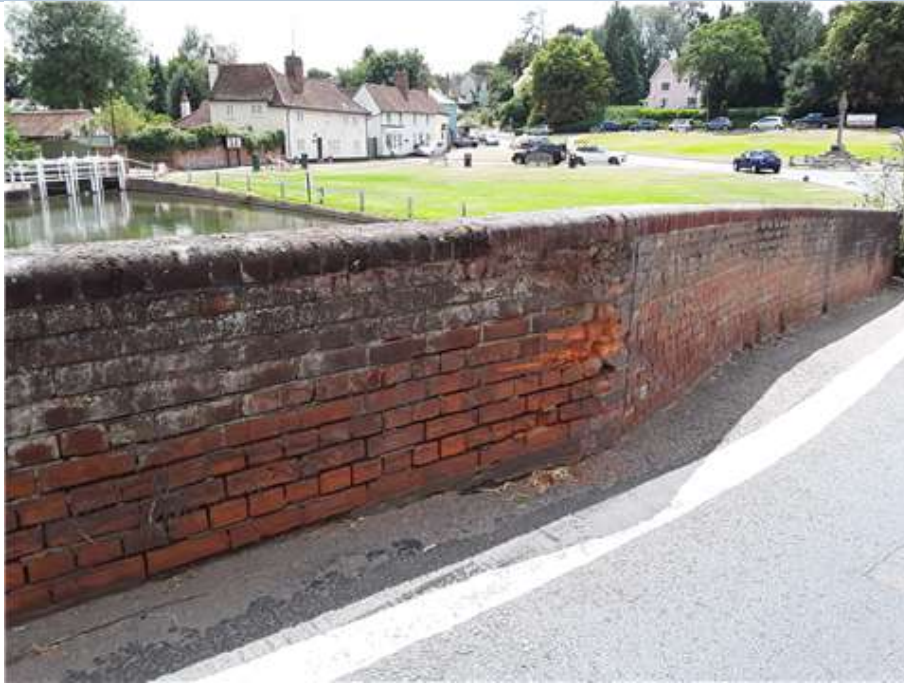
South Parapet - West Side

West end of inside face has suffered impact, causing moderate gouges and spalls to brickwork.

- West end of inside face has suffered impact causing moderate gouges and spalls to brickwork.
- East end of inside face has suffered impact causing gouges to brickwork and 2.4m of coping brickwork now missing.
- At North East corner, several bricks were missing to soldier course, likely caused by a vehicle impact.

Brickwork repairs to be carried out to parapets.

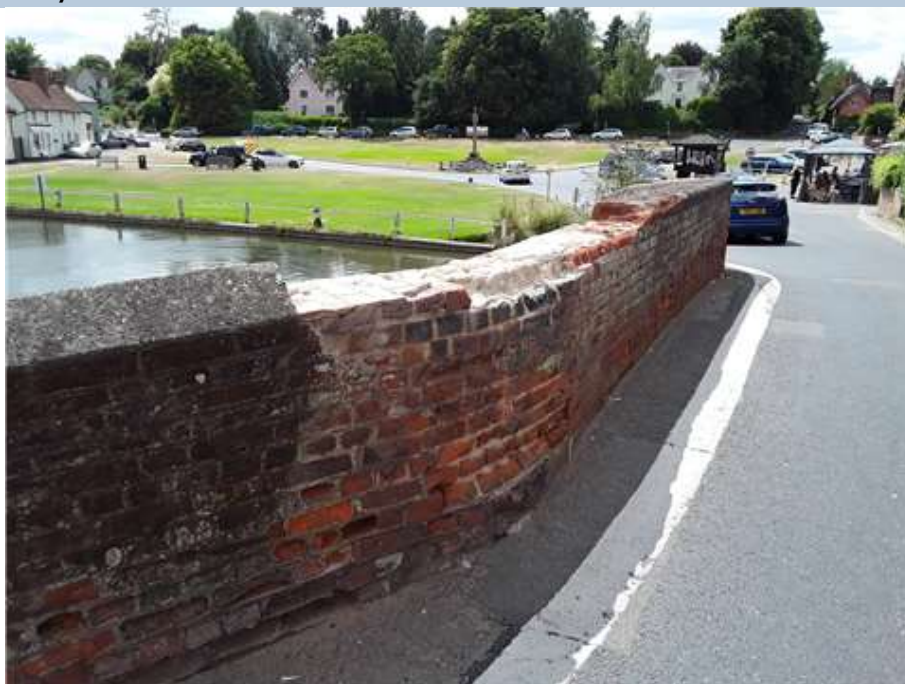
South Parapet - East Side
 East end of inside face has suffered impact causing gauges to brickwork and 2.4m of coping brickwork now missing.

- West end of inside face has suffered impact causing moderate gouges and spalls to brickwork.
- East end of inside face has suffered impact causing gauges to brickwork and 2.4m of coping brickwork now missing.
- At North East corner, several bricks were missing to soldier course, likely caused by a vehicle impact.

Brickwork repairs to be carried out to parapets.

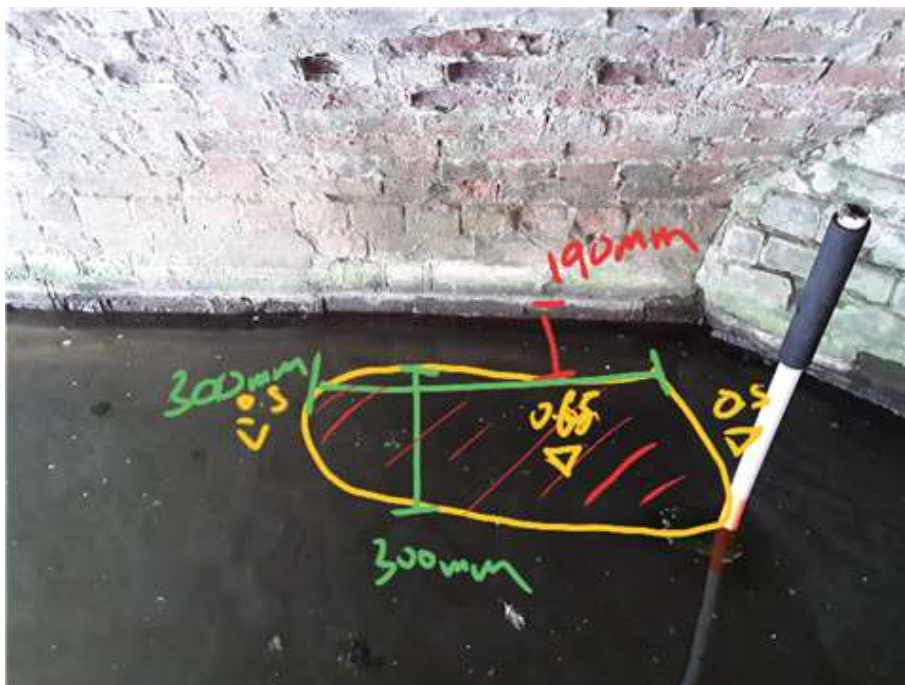
Minor Scour - North West
 Minor patch of scour 300mm² located at North West corner, 190mm in front of abutment. Scour patch has a 150mm difference in depth to surrounding area.

Minor patch of scour 300mm² located at north west corner, 190mm in front of abutment. Scour patch has a 150mm difference in depth to surrounding area.

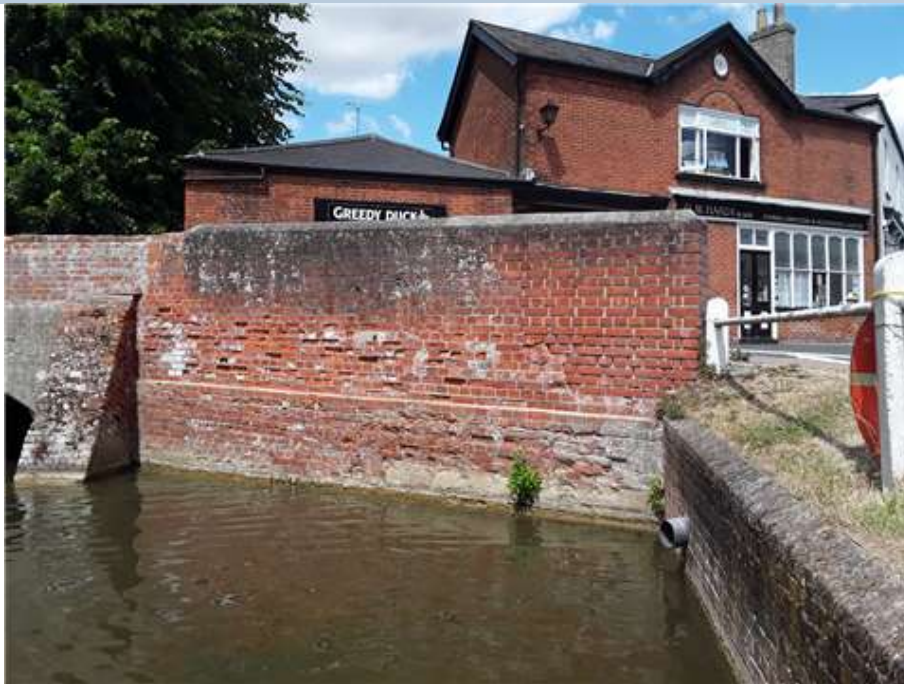
South East Wingwall

South East wingwall has areas of moderate erosion to brickwork reaching depths up to 35mm.

Comment	Remedial Works
South East wingwall had areas of moderate erosion to brickwork, reaching depths up to 35mm.	[none]

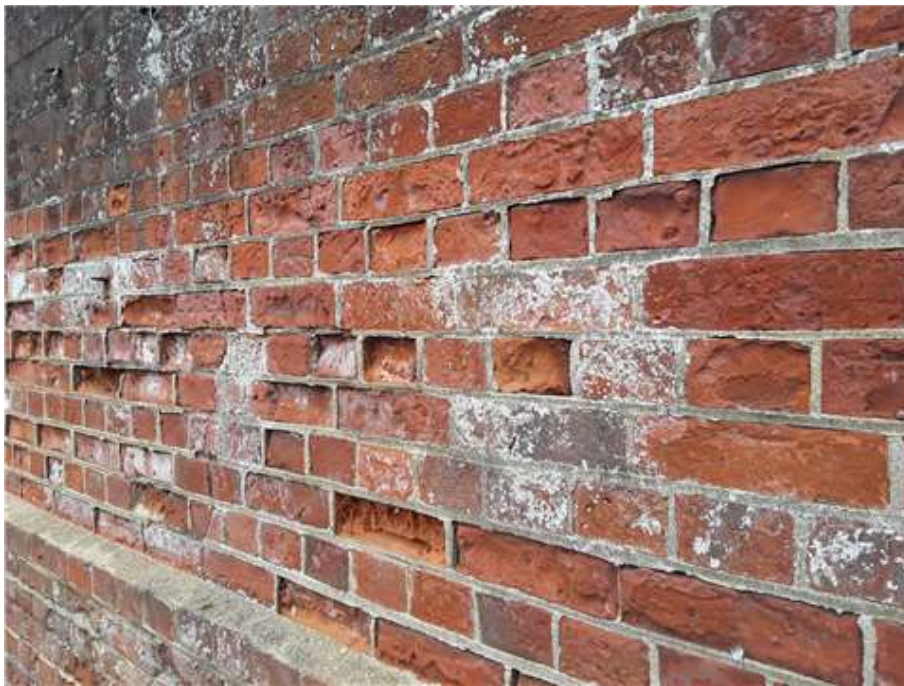
South East Wingwall - Example of Weathered Brickwork

South East wingwall has areas of moderate erosion to brickwork reaching depths up to 35mm.

Comment	Remedial Works
South East wingwall had areas of moderate erosion to brickwork, reaching depths up to 35mm.	[none]

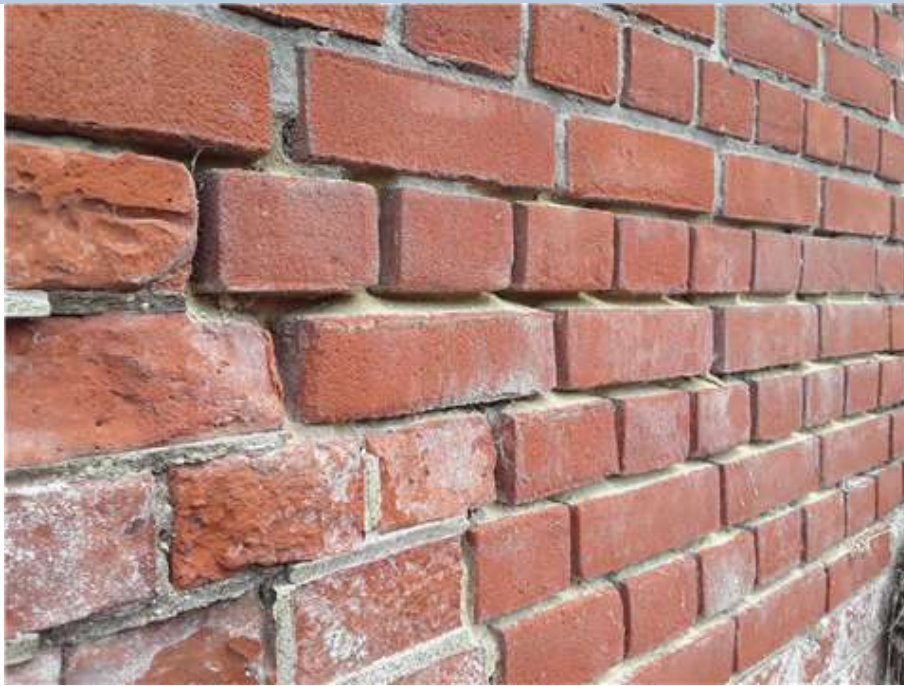
South East Wingwall - Moderate Deterioration of Pointing
 Moderate loss of pointing up to depths of 40mm in a 0.5m x 1m area.

Comment	Remedial Works
Moderate loss of pointing up to depths of 40mm in a 0.5m x 1m area.	[none]

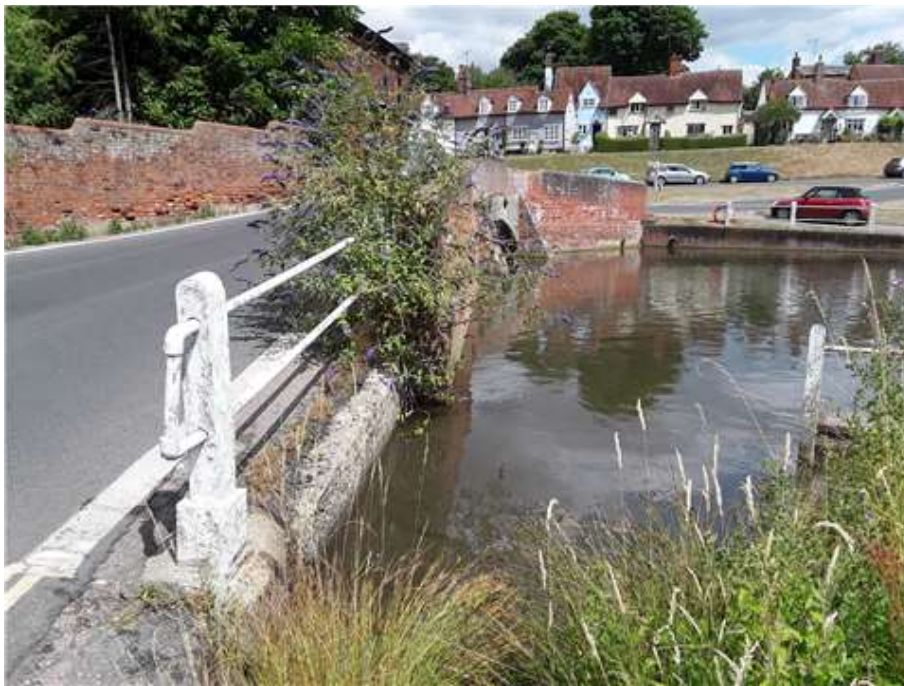
20220715_140521.jpg
 Upload/Link Photos to : 31 - 31/Wing walls

Comment	Remedial Works
Weeds/ Shrub growing at end of South West wingwall/ retaining wall. Shrub is most likely Buddleia (Butterfly Bush) and could potentially contribute to deterioration of brickwork.	Remove vegetation and prevent from further growth.

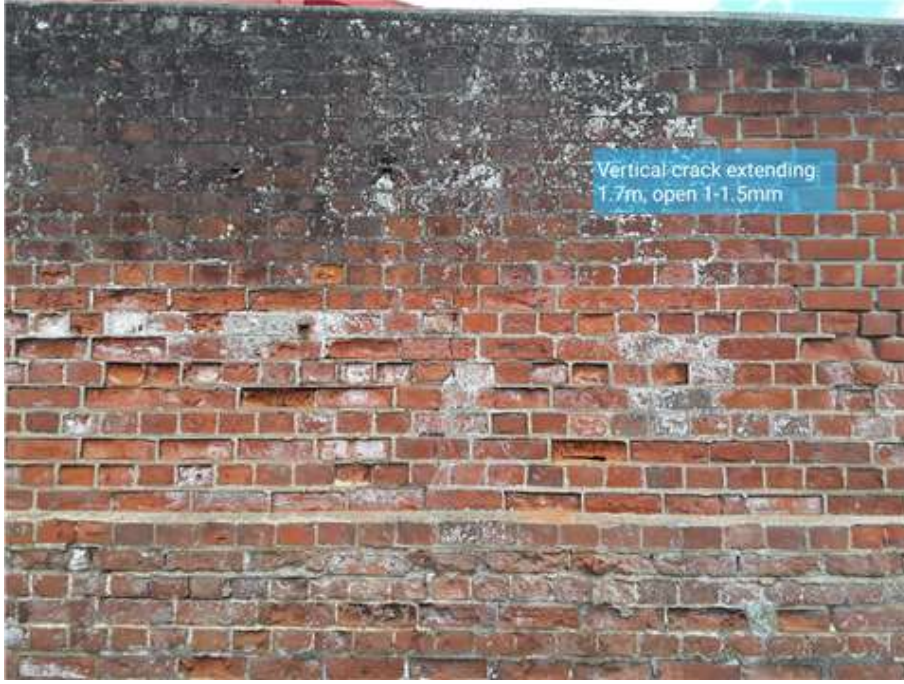
South East Wing Wall - Vertical Crack

South East wingwall has a vertical crack extending 1.7m (full height including both sides of wingwall parapet), open 1mm to 1.5mm.

Comment	Remedial Works
South East wingwall had a historic vertical crack extending 1.7m (full height including both sides of wingwall parapet), open 1mm to 1.5mm.	[none]
