Marks Tey Bridge - 18 March 2019

The photographs below illustrate recent progress made at Marks Tey Bridge.

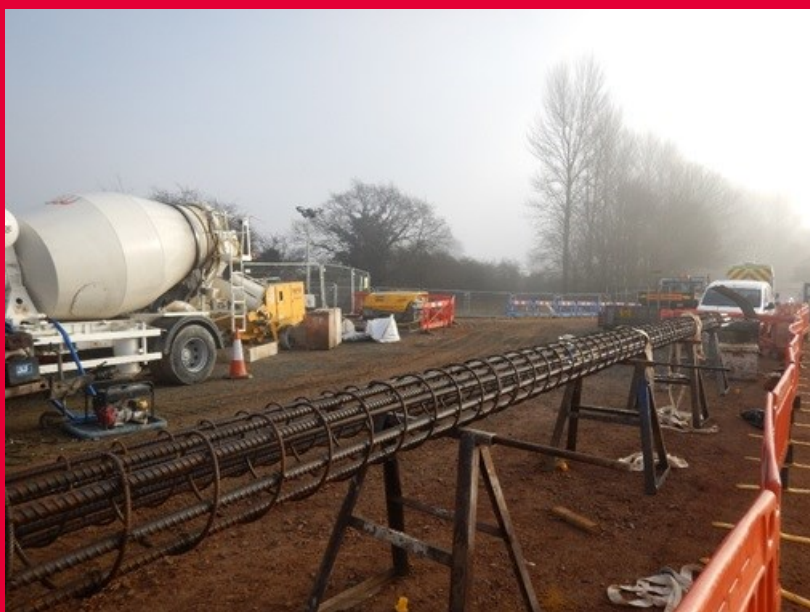
Above left: Reinforcement piles ready for installation. Above right: Piling operation temporarily stopped to allow an extension to the drilling system to be installed and the clearing of material to take place.

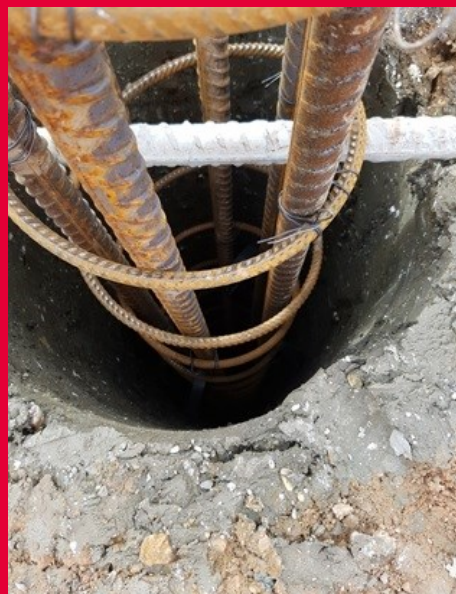
Above left: Reinforcement in the bored pile. Above right: Excavated to the formation level of the retaining wall with the top of the piles to be broken to the correct level.

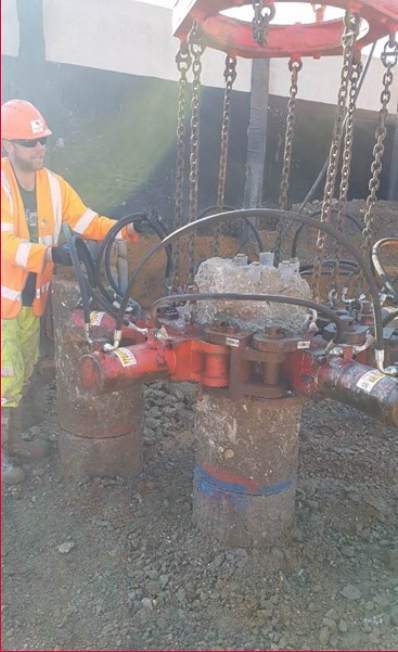
Above left: Pile cropper removing the top part of the pile. Above right: Placing of blinding concrete in progress.

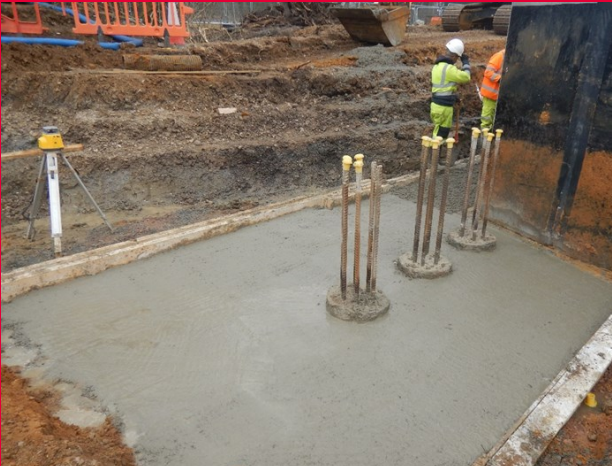
Above left: Blinding concrete completed ready for next phase. Above right: Site following recent downpour.
